Gordon Playground
Inspections LTD **PSSLive+**

Annual Inspection 2024

Gorse Covert

Patchway Parish Council

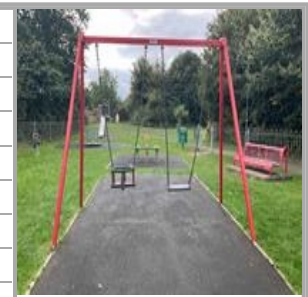
Asset	1 Bay 1 Flat 1 Cradle Seat Swing
Finding Group	Maintenance
Finding Title	Item - Graffiti - Present
Standard Reference	
Standard Description	Graffiti present
Finding Notes	
Cause	Vandalism
Finding Creation Date	04/10/2024 15:01:10
Risk Value Text	1 x 1 = 1
Risk Level	Very Low
Resolve By Date	21/03/2025 14:01:28
Finding Status	Open

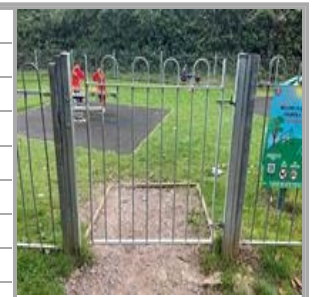
Asset	Pedestrian Gate
Finding Group	Maintenance
Finding Title	Surface - Trip points
Standard Reference	
Standard Description	Trip points
Finding Notes	
Cause	Wear and Tear
Finding Creation Date	04/10/2024 14:55:25
Risk Value Text	2 x 3 = 6
Risk Level	Low
Resolve By Date	27/12/2024 13:55:39
Finding Status	Open

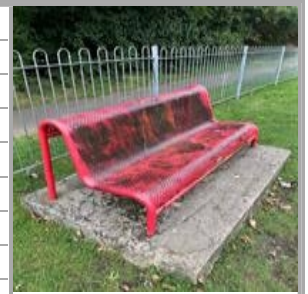
Asset	Seat
Finding Group	Maintenance
Finding Title	Item - Corrosion
Standard Reference	
Standard Description	Item has corrosion
Finding Notes	
Cause	Wear and Tear
Finding Creation Date	04/10/2024 14:57:50
Risk Value Text	1 x 2 = 2
Risk Level	Very Low
Resolve By Date	04/10/2025 14:58:03
Finding Status	Open

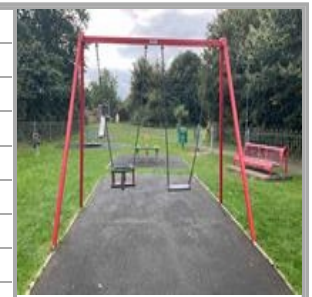
Asset	1 Bay 1 Flat 1 Cradle Seat Swing
Finding Group	Maintenance
Finding Title	Chain - Links Worn
Standard Reference	
Standard Description	Chain links notched
Finding Notes	
Cause	Wear and Tear
Finding Creation Date	12/10/2022 11:43:31
Risk Value Text	1 x 3 = 3
Risk Level	Very Low
Resolve By Date	23/07/2024 12:23:47
Finding Status	Closed

Task Title	Change chains links / connectors to those meeting ISO 1834 when worn
Task Notes	
Task Status	Completed

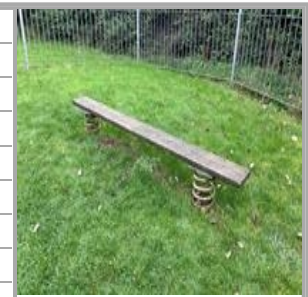
Asset	Balance Trail
Finding Group	Maintenance
Finding Title	Item - Loose in Ground
Standard Reference	
Standard Description	Loose in ground
Finding Notes	End support spring ground fixing loose .
Cause	Wear and Tear
Finding Creation Date	25/07/2022 11:17:21
Risk Value Text	1 x 2 = 2
Risk Level	Very Low
Resolve By Date	20/04/2023 13:30:11
Finding Status	Open

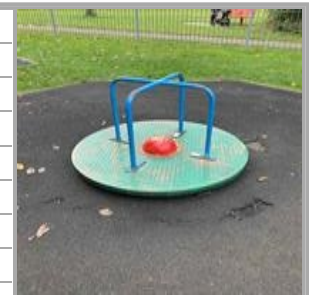
Asset	Carousel
Finding Group	Maintenance
Finding Title	Carousel - Bearings - Worn
Standard Reference	
Standard Description	Excessive movement or noisy operation.
Finding Notes	Some minor bearing wear noticed. Slowly getting worse 24/9/24
Cause	Wear and Tear
Finding Creation Date	04/10/2021 10:34:51
Risk Value Text	1 x 3 = 3
Risk Level	Very Low
Resolve By Date	11/04/2024 10:06:24
Finding Status	Open

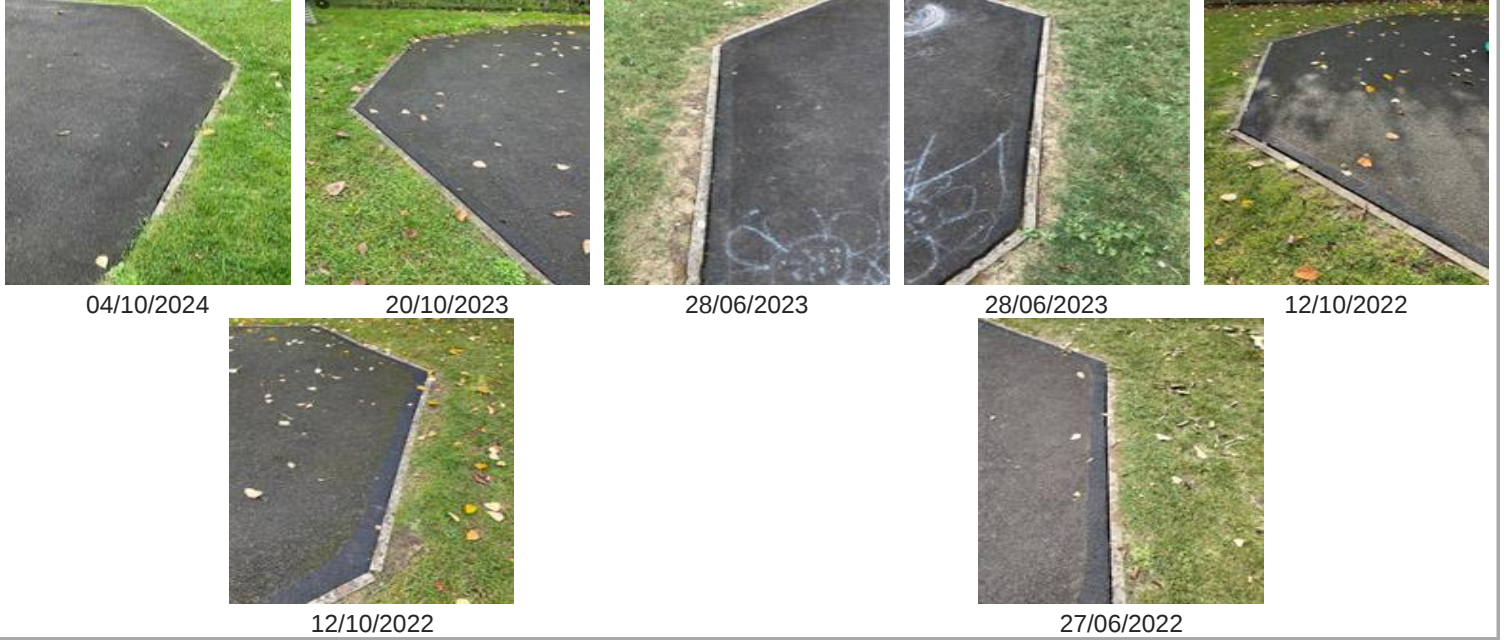
Asset	Carousel Surface
Finding Group	Maintenance
Finding Title	Surface - Edges Shrunk
Standard Reference	
Standard Description	Surface - Edges Shrunk
Finding Notes	12.10.22 Condition deteriorated 28.6.23 getting worse ..and has been reported to office for all surfaces
Cause	Wear and Tear
Finding Creation Date	27/06/2022 10:40:02
Risk Value Text	1 x 3 = 3
Risk Level	Very Low
Resolve By Date	25/06/2024 15:52:08
Finding Status	Open

Task Title	Repair edges
Task Notes	
Task Status	Assigned

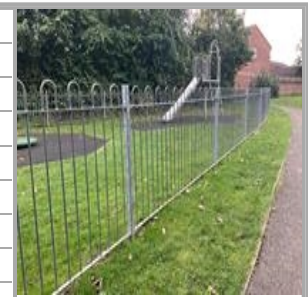
Asset	Fence
Finding Group	Maintenance
Finding Title	Fixtures - Loose or Missing
Standard Reference	
Standard Description	Fixtures loose or missing
Finding Notes	
Cause	Wear and Tear
Finding Creation Date	20/10/2023 11:38:33
Risk Value Text	1 x 1 = 1
Risk Level	Very Low
Resolve By Date	05/04/2024 11:38:49
Finding Status	Open

Task Title	Replace missing fasteners, fixtures and fitting
Task Notes	
Task Status	Unapproved

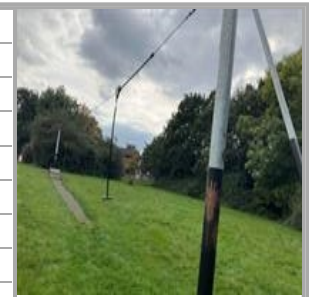
Asset	Field - Cableway
Finding Group	Maintenance
Finding Title	Brakes Worn
Standard Reference	
Standard Description	Brakes Worn
Finding Notes	Needs fixing by manufacturer
Cause	Wear and Tear
Finding Creation Date	11/07/2022 08:47:49
Risk Value Text	1 x 3 = 3
Risk Level	Very Low
Resolve By Date	20/04/2023 14:17:41
Finding Status	Open

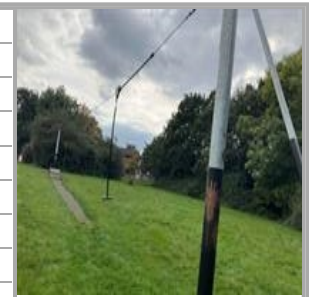
Asset	Field - Cableway
Finding Group	Maintenance
Finding Title	Item - Parts Missing
Standard Reference	
Standard Description	Item has some parts missing
Finding Notes	Finger plates missing from traveller.needs fixing by manufacturer
Cause	Installation Defect
Finding Creation Date	11/07/2022 08:45:32
Risk Value Text	2 x 4 = 8
Risk Level	Low
Resolve By Date	25/06/2024 16:14:56
Finding Status	Open

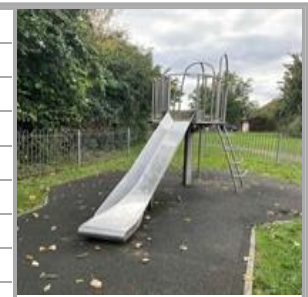
Asset	Junior Multiplay
Finding Group	Maintenance
Finding Title	Item - Cap(s) missing
Standard Reference	
Standard Description	Cap(s) missing
Finding Notes	Caps missing from various fixings on unit 22/03/2021
Cause	Vehicle Nuisance
Finding Creation Date	14/10/2019 12:30:00
Risk Value Text	
Risk Level	Low
Resolve By Date	13/07/2023 13:59:55
Finding Status	Open

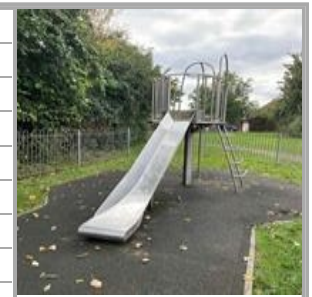
Asset	Junior Multiplay
Finding Group	Maintenance
Finding Title	Fixtures - Loose or Missing
Standard Reference	
Standard Description	Fixtures loose or missing
Finding Notes	
Cause	Wear and Tear
Finding Creation Date	14/10/2019 12:30:00
Risk Value Text	2 x 3 = 6
Risk Level	Low
Resolve By Date	05/07/2023 10:09:48
Finding Status	Open

Task Title	Replace
Task Notes	
Task Status	Unapproved

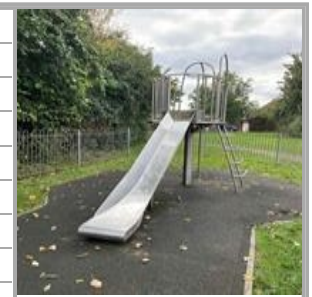
Asset	Junior Multiplay
Finding Group	Maintenance
Finding Title	Item - Parts Missing
Standard Reference	
Standard Description	Item has some parts missing
Finding Notes	
Cause	Wear and Tear
Finding Creation Date	14/10/2019 12:30:00
Risk Value Text	1 x 3 = 3
Risk Level	Very Low
Resolve By Date	25/06/2024 15:59:05
Finding Status	Open

Task Title	Replace missing fasteners, fixtures and fitting
Task Notes	
Task Status	Assigned

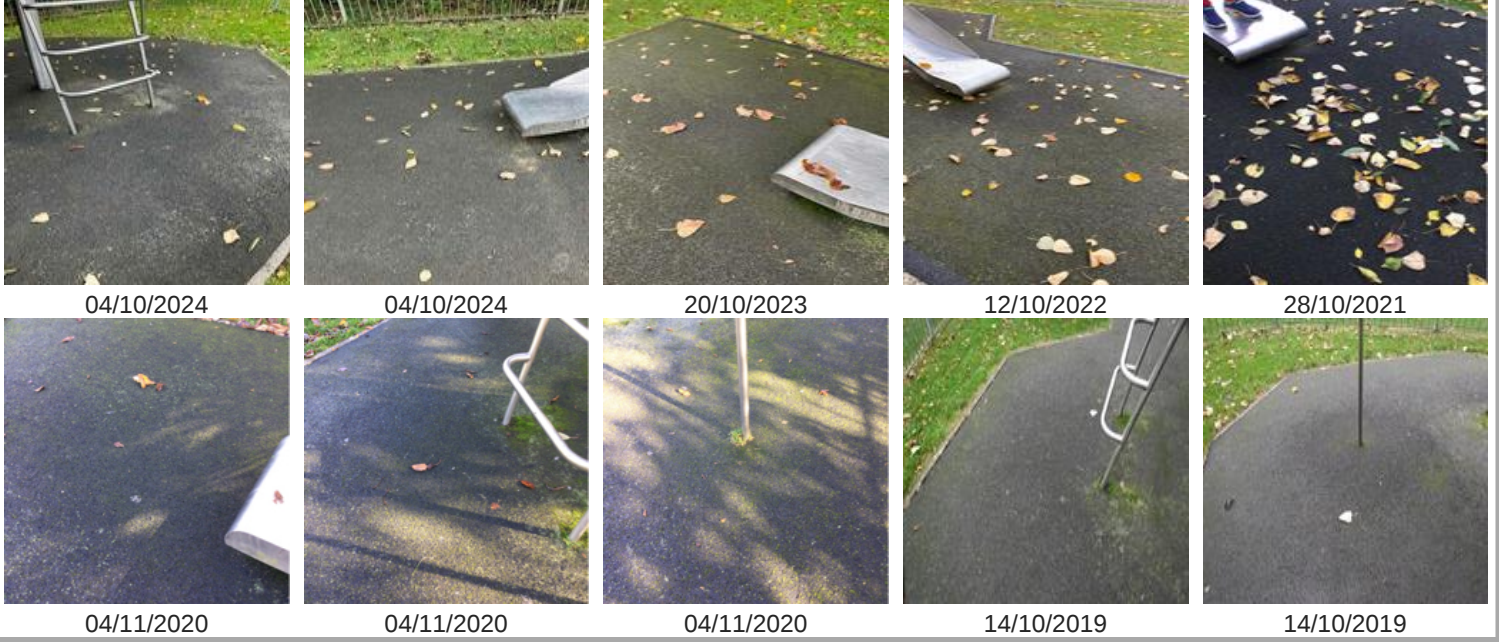
Asset	Junior Multiplay Surface
Finding Group	Maintenance
Finding Title	Surface - Wearing
Standard Reference	
Standard Description	Surface wearing
Finding Notes	
Cause	Wear and Tear
Finding Creation Date	14/10/2019 12:30:00
Risk Value Text	1 x 3 = 3
Risk Level	Very Low
Resolve By Date	26/01/2024 14:03:34
Finding Status	Open

Task Title	Monitor
Task Notes	
Task Status	Assigned

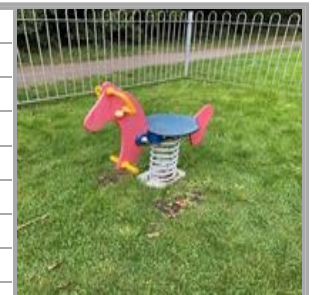
Asset	Rocker Horse
Finding Group	Maintenance
Finding Title	Fixtures - Loose or Missing
Standard Reference	
Standard Description	Fixtures loose or missing
Finding Notes	Spring to base fixings are loose. 27/12/2021 - increased movement.
Cause	Wear and Tear
Finding Creation Date	04/10/2021 10:38:49
Risk Value Text	2 x 3 = 6
Risk Level	Low
Resolve By Date	20/11/2024 09:21:09
Finding Status	Open

Task Title	Replace
Task Notes	
Task Status	Assigned

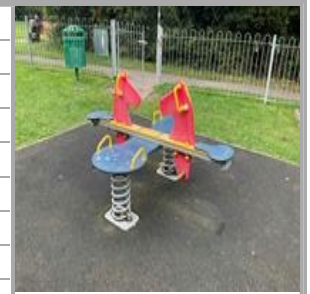
Asset	Rocker Seesaw
Finding Group	Maintenance
Finding Title	Item - Graffiti - Present
Standard Reference	
Standard Description	Graffiti present
Finding Notes	
Cause	Vandalism
Finding Creation Date	24/09/2024 13:42:27
Risk Value Text	
Risk Level	Very Low
Resolve By Date	22/10/2024 13:43:30
Finding Status	Open

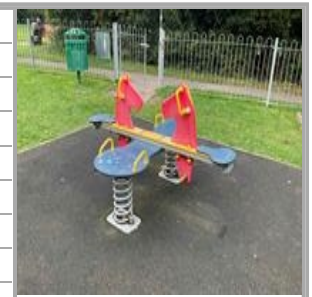
Asset	Rocker Seesaw
Finding Group	Maintenance
Finding Title	Fixtures - Loose or Missing
Standard Reference	
Standard Description	Fixtures loose or missing
Finding Notes	
Cause	Wear and Tear
Finding Creation Date	14/10/2019 12:30:00
Risk Value Text	1 x 2 = 2
Risk Level	Very Low
Resolve By Date	27/09/2023 10:12:37
Finding Status	Open

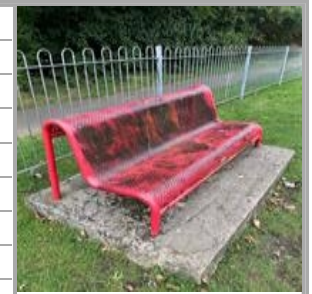
Asset	Seat
Finding Group	Maintenance
Finding Title	Item - Hard or Sharp Projections
Standard Reference	
Standard Description	Hard or sharp projections
Finding Notes	Needs replacing has come to end of life
Cause	Wear and Tear
Finding Creation Date	14/10/2019 12:30:00
Risk Value Text	2 x 2 = 4
Risk Level	Low
Resolve By Date	13/10/2023 12:55:11
Finding Status	Open

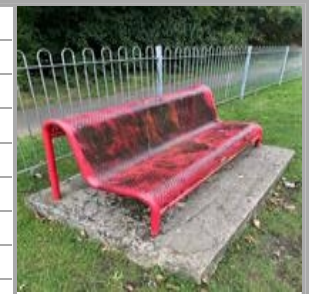
Asset	Seat
Finding Group	Maintenance
Finding Title	Item - Damaged
Standard Reference	
Standard Description	Item is damaged
Finding Notes	Concrete base uneven
Cause	Wear and Tear
Finding Creation Date	14/10/2019 12:30:00
Risk Value Text	2 x 3 = 6
Risk Level	Low
Resolve By Date	14/01/2020 12:30:00
Finding Status	Open

Task Title	Repair item
Task Notes	
Task Status	Assigned

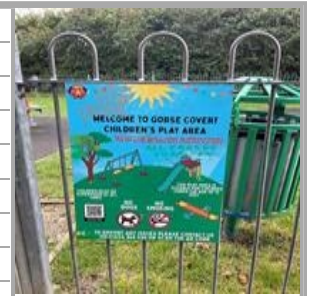
Asset	Signage
Finding Group	Maintenance
Finding Title	Item - Graffiti - (offensive) Present
Standard Reference	
Standard Description	Graffiti (offensive) present
Finding Notes	
Cause	Vandalism
Finding Creation Date	24/09/2024 13:46:32
Risk Value Text	
Risk Level	Very Low
Resolve By Date	01/10/2024 13:47:20
Finding Status	Open
